MERRIMACK RIVER BASIN
NORTH ANDOVER, MASSACHUSETTS

LAKE COCHICHEWICK OUTLET DAM
MA 00278

PHASE I INSPECTION REPORT
NATIONAL DAM INSPECTION PROGRAM

DECEMBER 1978

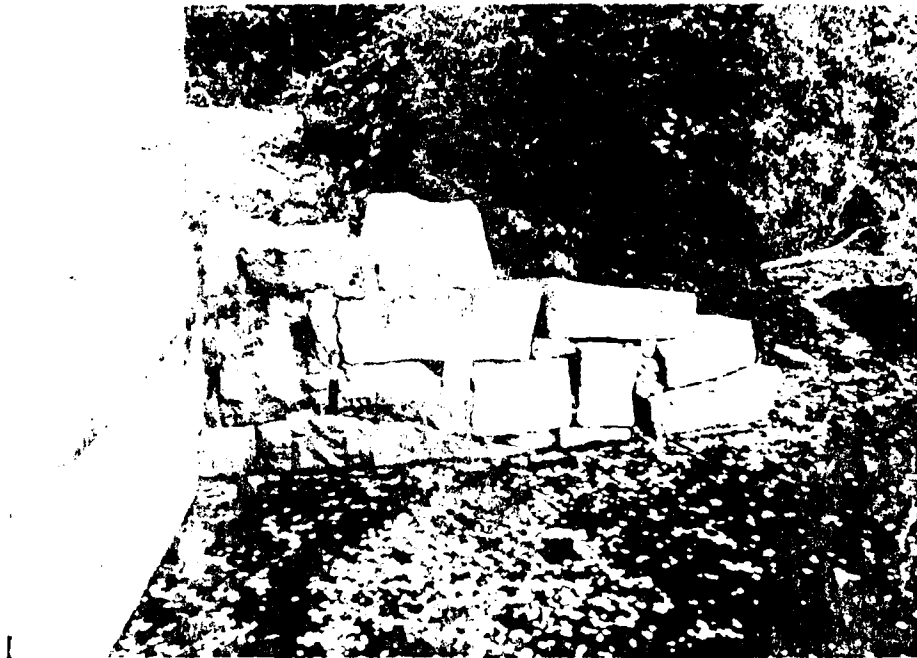
a. Obstructions	None observed
b. Channel bottom	Not visible
c. Channel wells	Granite masonry walls with upper mortared. Most of the mortar is missing. Voids present in left and right walls and blocks are displaced. Soil has eroded behind right wall

d. Log boom, screens, etc	None - water level gage cut into right wall
e. General structural condition	Due to presence of voids, displaced blocks and loss of backfill, the condition of the intake is considered fair
<u>2. Control Facility</u>

6. Right approach channel wall

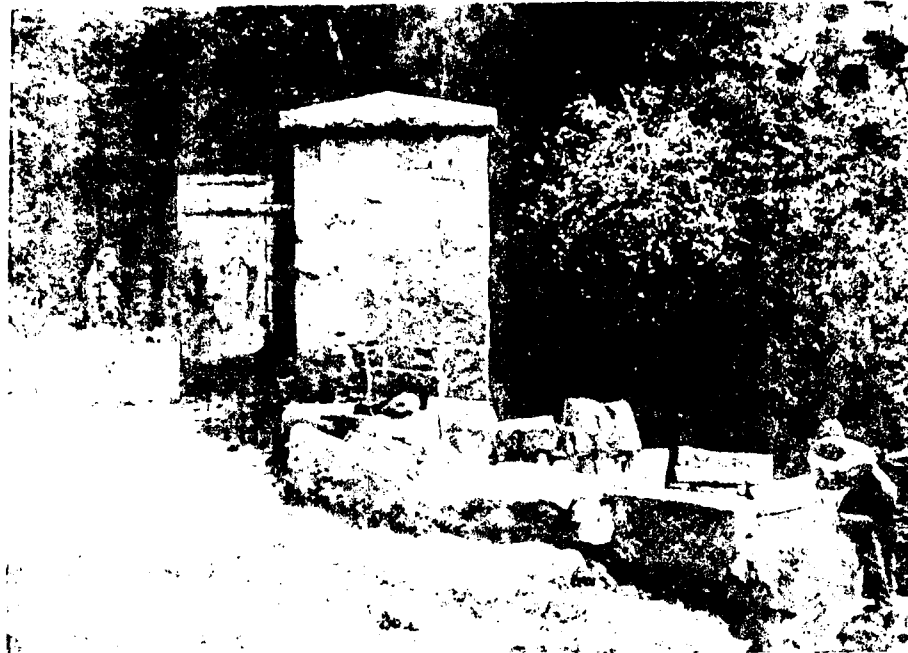
4. Left side of gate structure

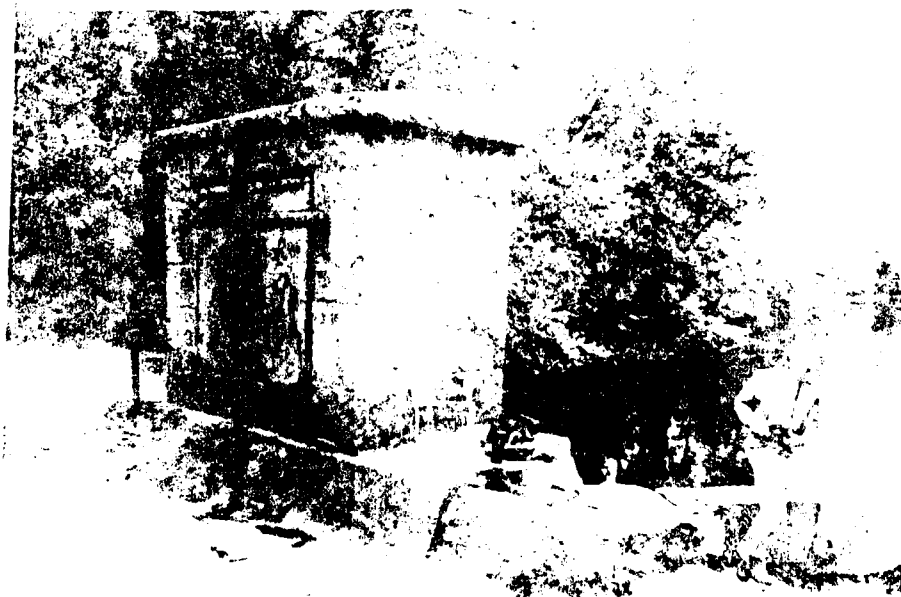
5. Gate structure and left approach channel wall

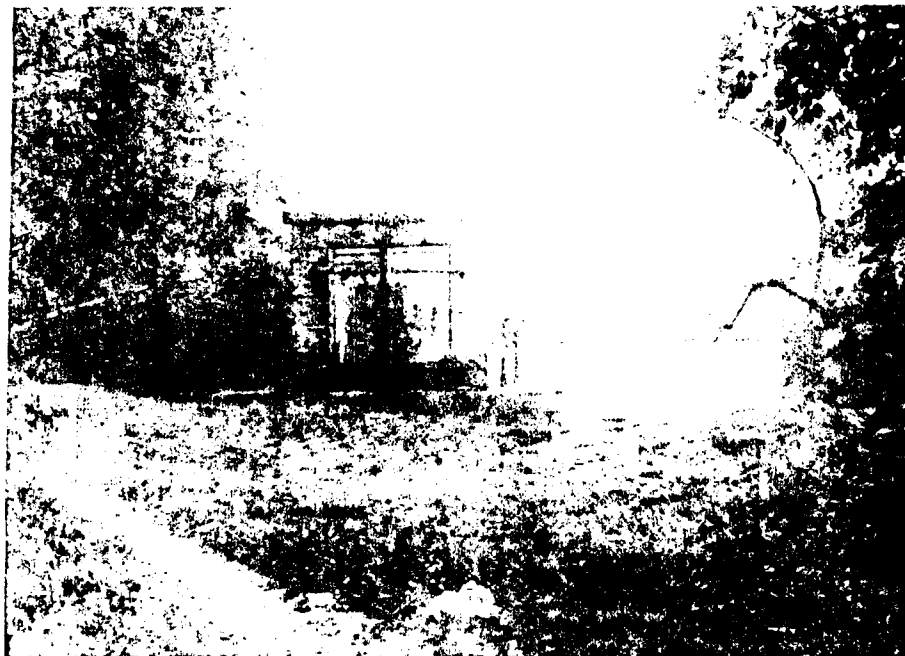
1. Downstream view of gate structure
